Model	QQ 7110	Trouble Category	Electrical
Road Mileage	8,000 KM

The right front door glass DOWN automatically.

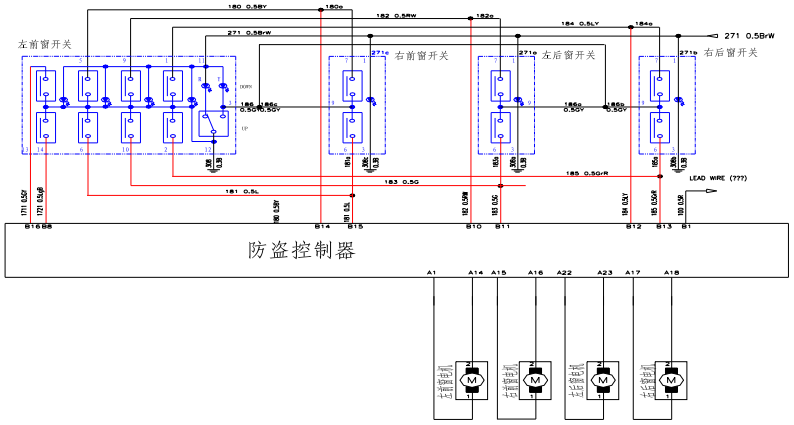
The QQ glass UP/DOWN signal is an earthing signal, and easily subject to be interfered after the water intake. In addition, the fault also represents as: after the vehicle is locked using its remote controller, the glass doesn¡t UP or UP and then DOWN. The reason to result this symptom is the glass switch UP/DOWN signal failure, water intake, cable wear broken and earthing, and other failures (the red circuits are easily subject to the problem, and the blue circuits are the glass UP/DOWN switches).

According to the owner¡s feedback, we know that the problem occurs after the vehicle is rinsed. Later, carefully check the four door switch signals, and then find that there are some water traces in the right front door switches. After these switches are dried, the trouble is removed.

The water enters into the right front door switches, and the trouble is removed after these switches are dried.
